TOWN OF WARRENTON
2018 CDBG-NEIGHBORHOOD REVITALIZATION PROJECT

UNIT #9
108 Brehon Street
Warrenton, NC 27589

Subject: **Limited Lead-Based Paint Inspection/Risk Assessment**
108 Brehon Street – Warrenton, NC
SUMMIT Project No. 8886.E0007

Limited Lead-Based Paint Inspection (XRF)

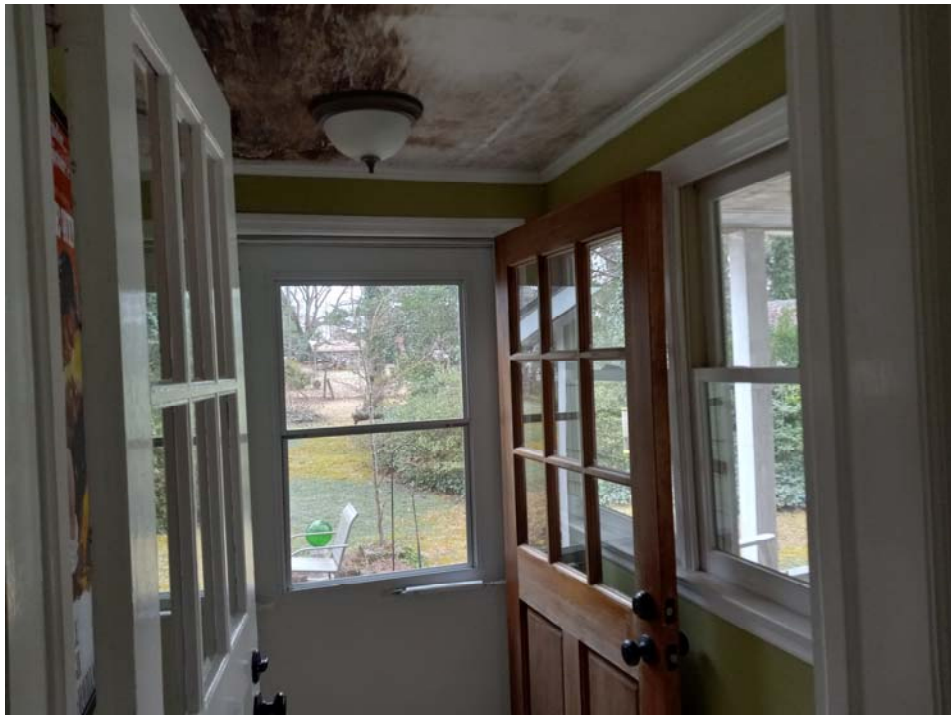
Photo #2: Mudroom Damaged Ceiling

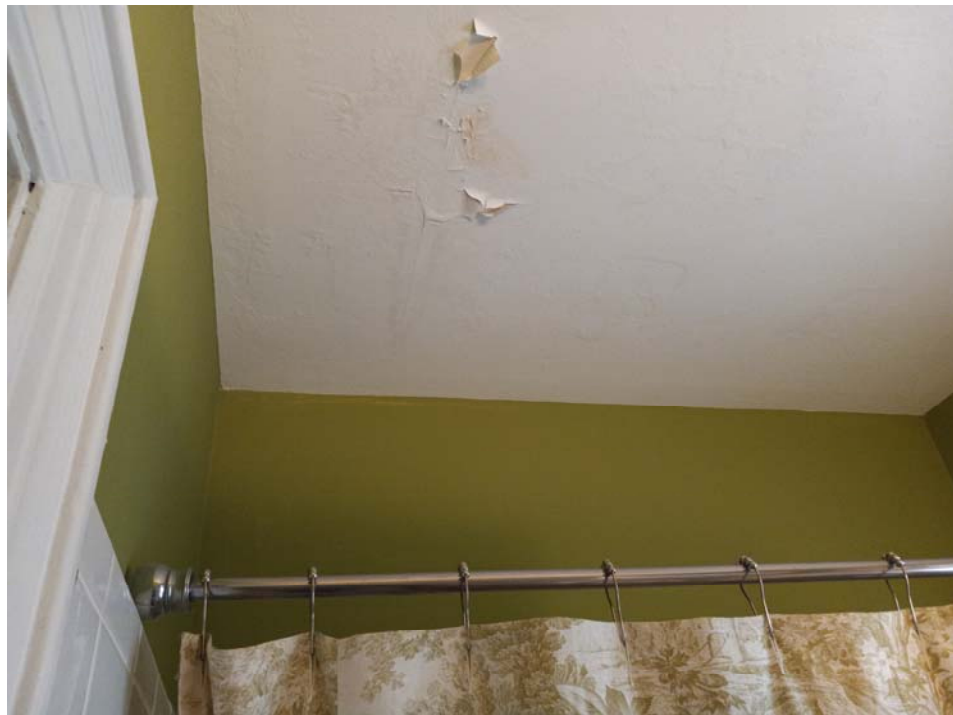
Photo #4: Peeling Paint – Bathroom Ceiling

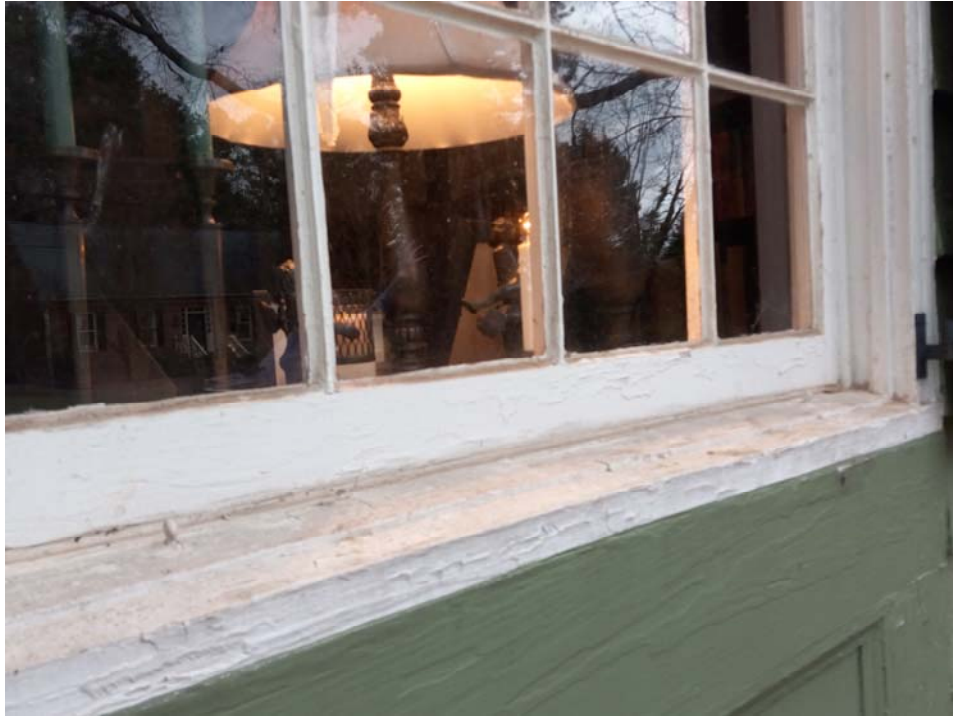
Photo #5: Peeling Exterior Window Components

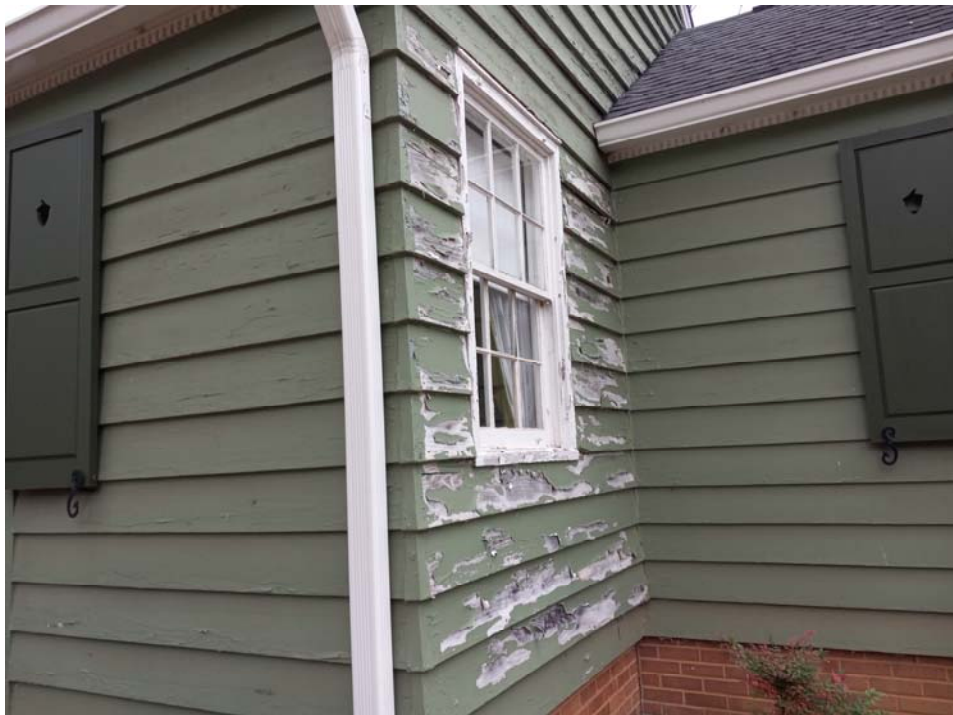
Photo #6: Peeling Siding

Unit Number Common Area, or Exterior Location	Room or Room Equivalent	Building Component	Type of Hazard*	Lead Level (mg/cm ² or µg/g)**	Options for Corrective Action
	Exterior	Siding	deteriorated	1.5-4.7	Interim control = cover with vinyl siding Abatement = enclosure, or complete removal of paint and repaint, or encapsulate
	Exterior	Window casing	deteriorated	3.3-4.7	Interim control = scrap paint and repaint Abatement = replace windows, or enclose in aluminum
	Exterior	Windowsill	deteriorated	3	Interim control = scrap paint and repaint Abatement = replace windows, or enclose in aluminum
	Exterior	Door panel	deteriorated	3.3	Interim control = scrap paint and repaint Abatement = replace door, or complete removal of lead paint and repaint
