**BIDDING AND CONTRACT DOCUMENTS  
FOR THE  
CITY OF RALEIGH, NORTH CAROLINA  
STORMWATER REHABILITATION PROEJCT**

**ADDENDUM NO. 1**

## Technical Memorandum

*Subject: Assessment of 96-in Junction Box Below SW Worth Street*

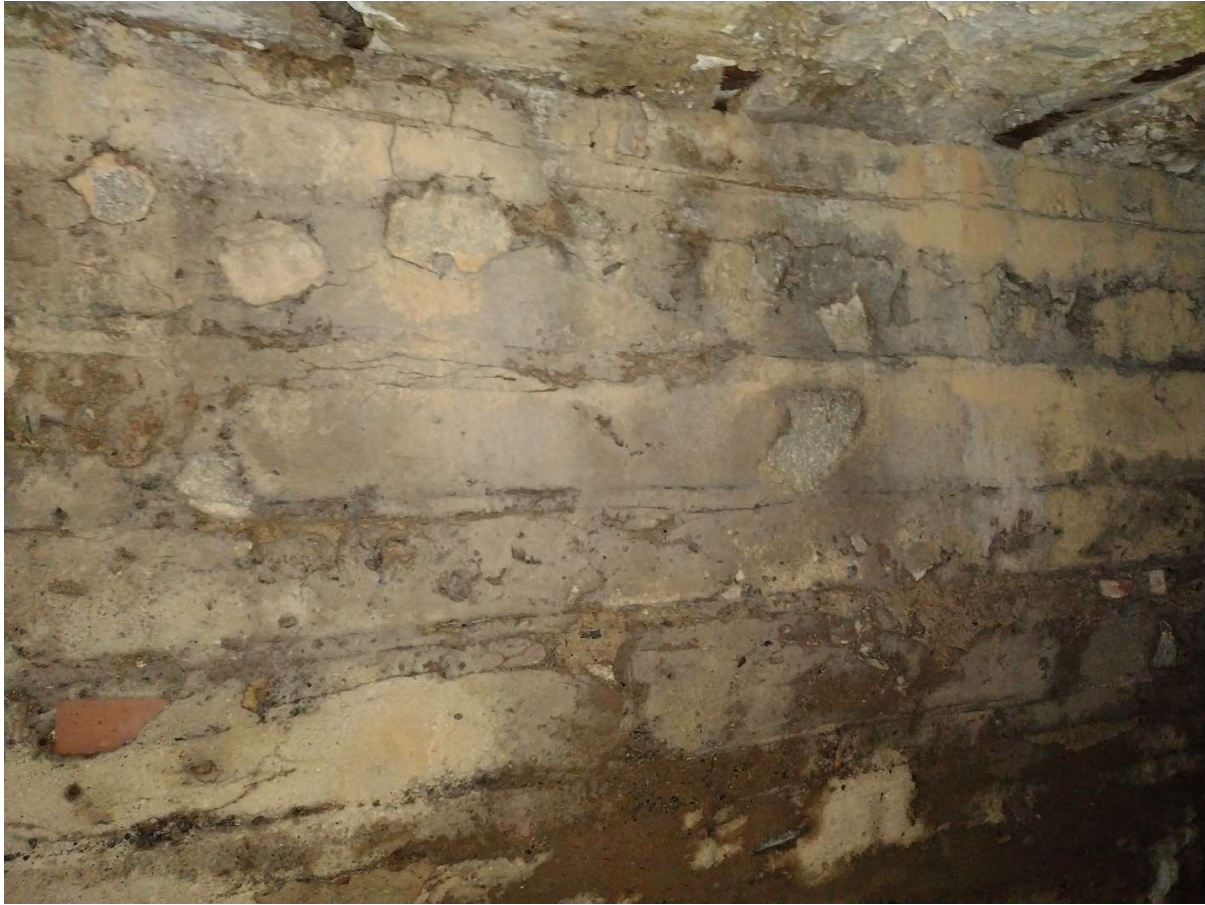
The Worth St structure appears to be constructed of mixed materials. From what could be observed, it seems that the walls of the box are actually constructed of stone, masonry, and/or large concrete sections fitted together and covered with a cementitious mortar coat, often referred to as a “parge” coat (**Figure 2**). The parge coat was thickly applied to form a relatively flat wall surface, but the substrate is visible in various locations. At one location, what looks like a repair of a vertical crack in the box wall was observed (**Figure 3**). The end of the junction box was measured to be approximately 13 feet from the edge each of the storm drain openings on the North and the South end. No settlement, lateral movement, or significant cracking in the walls were identified that would suggest oversteering or failure in the Worth St box.

**Figure 2. Typical Masonry Wall for Worth Box. Encased Steel Beams in Top ab visible above.**

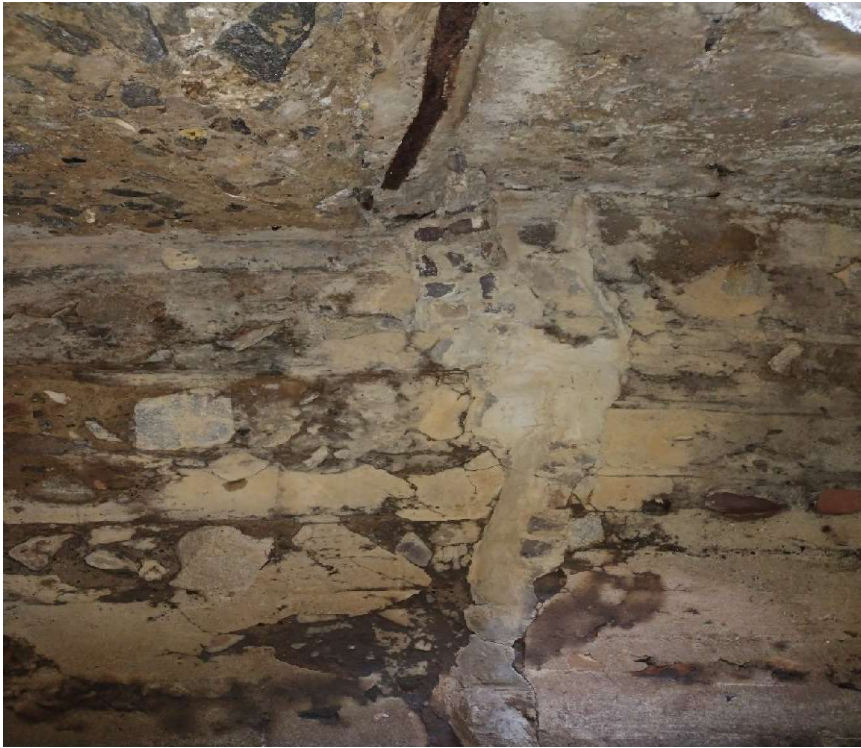
**Figure 3. Repaired crack in box wall. No evidence of leaking or continued movement were observed.**

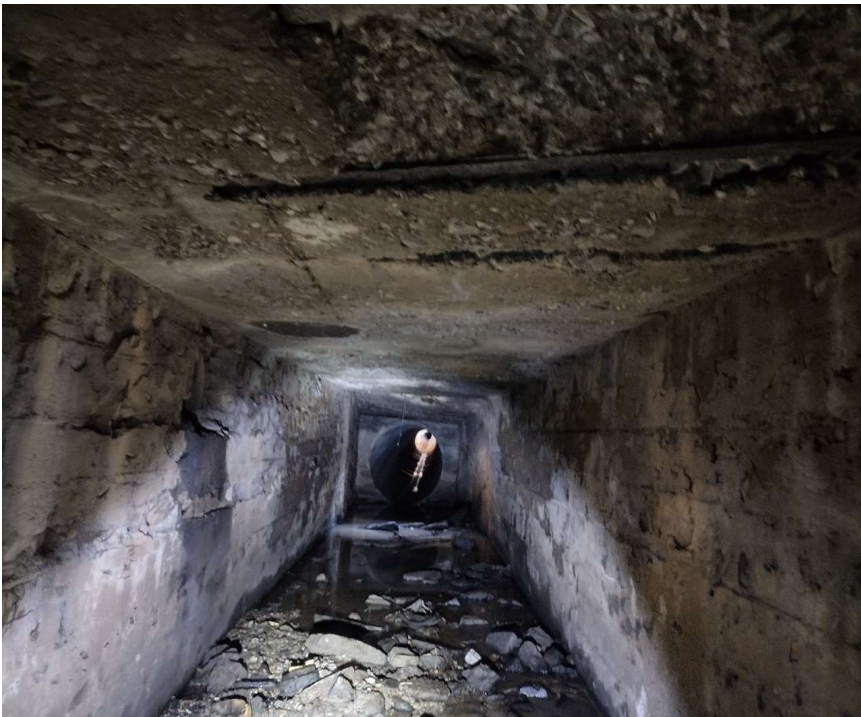
There appears to be no floor slab or cast footing in the bottom of the box, with an uneven layer of rock/riprap serving as the bottom (**Figure 4**). Due to the standing water in the box, it was not possible to verify that the base of the wall was not exposed. Even so, it does appear that the riprap is adequately covering the base of the walls at the time of inspection.

**Figure 4. Interior view of Worth St box showing floor, walls, and top slab.**

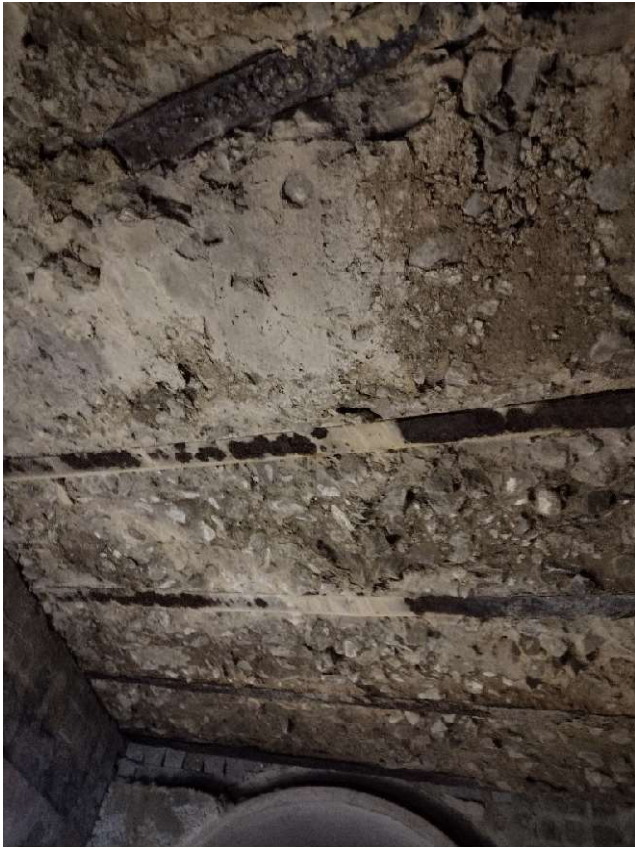
**Figure 5. View of degradation on bottom of top slab at end of Worth St box.**

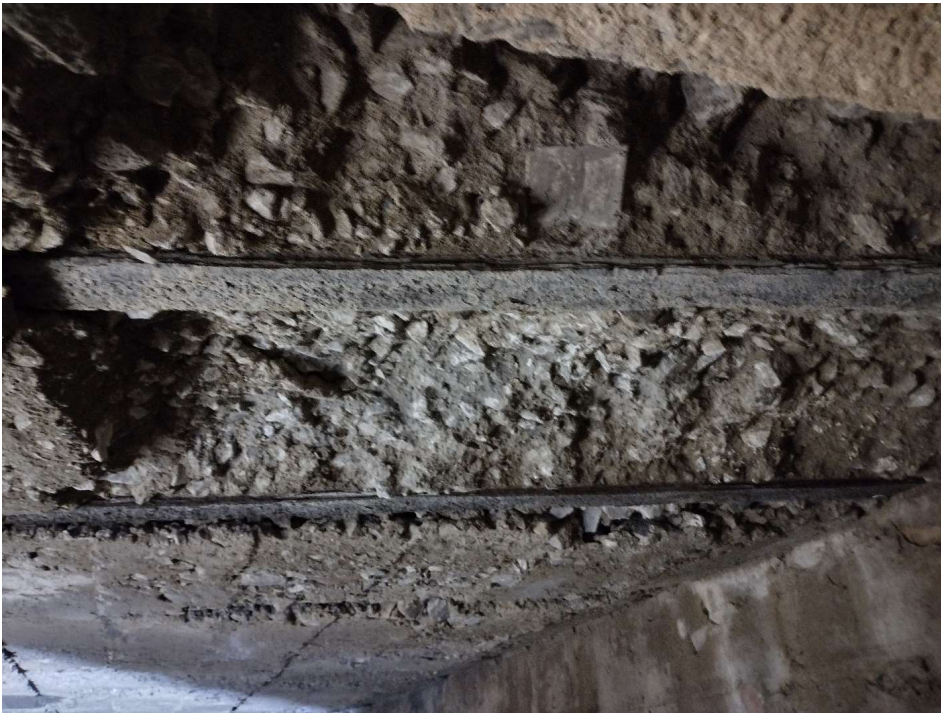
The encased steel beams are roughly spaced 2 feet on center. In the locations where the steel members are exposed, they are significantly corroded. No sagging or cracking was observed in the top slab, but there were areas where there was significant spalling around and between the beams. A large percentage of the members were exposed, and it was clear that there was substantial section loss of the steel and the concrete surface (**Figure 5 and 6**). Since the original dimensions of the steel beams is unknown, it is impossible to determine how much section loss has taken place. Based on the less progressed degradation of the top slab in the Bloodworth box, it seems likely that the steel was too close to the concrete surface and began to corrode. This corrosion resulted in expansion that cracked and spalled the concrete. This cycle continued as more of the steel was exposed and resulted in the widespread degradation currently seen. It is possible that the steel members were used as left in place support for forming and concrete placement, but it seems more likely that they were intended as structural support for the top slab to span between the walls. The fact that no reinforcement was observed in the heavily spalled areas at least indicates that there is no reinforcement in approximately the bottom 2 inches. It is still possible that there is rebar in the top half of the slab, but there is no way to confirm that without destructive testing. As a result, it was assumed that the steel members are part of the structural system. A ductile iron pipe was noted embedded in the top slab of the Worth St box. There was a gap around the pipe and what appears to be wood beams, likely used for forming and left in place, were visible (**Figure 7**).

**Figure 6. Visible steel corrosion and section loss of concrete between beams.**

Option 3 would be similar to Option 1 with the addition of some smaller remediation measures. A rust inhibitor would be applied to the exposed steel to help stop corrosion and the concrete spalling it leads to. Non-shrink grout could be used to fill any large voids (such as the exposed pipe shown in Figure 7) to help create a more uniform surface for the proposed cementitious lining. This will aid in stabilizing and sealing off areas that may not be easily lined. This coating and any grout fill would be applied prior to the already proposed cementitious coating that will line the interior of the box as part of the I/I remediation. While this will not act as a permanent fix to the existing conditions, it should be adequate to keep conditions from deteriorating further and extend the useful life of the existing system.

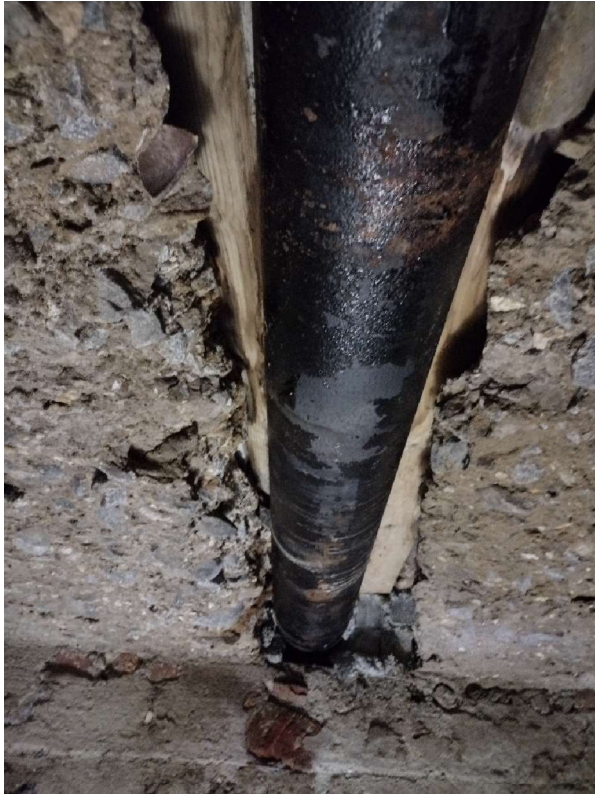
**Figure 7. Embedded DIP in top slab of Worth St box with visible wood.**

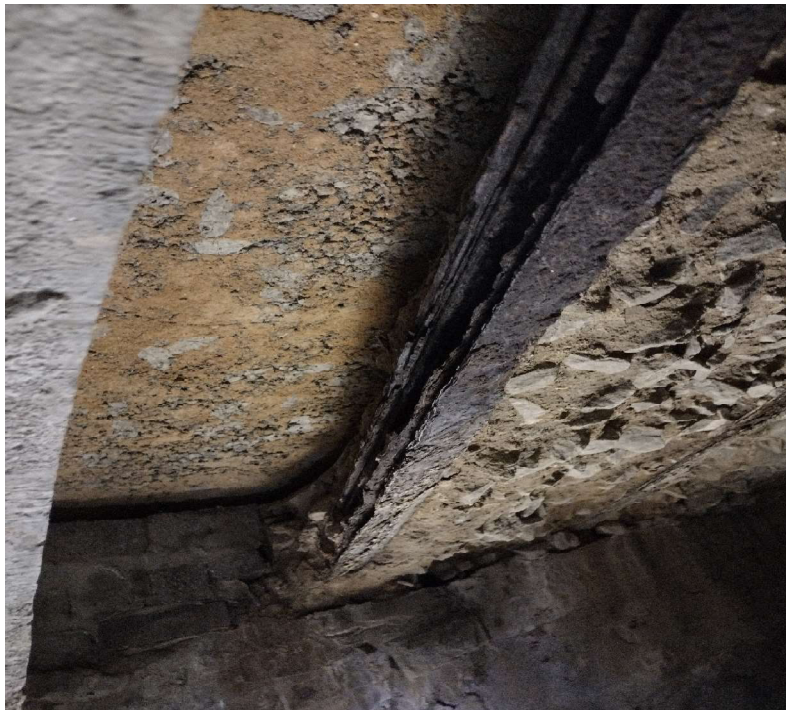
Based on the appearance of the concrete, it does seem likely to be relatively old. When compared to the newer concrete placed at the interface between the junction box and the new RCP end wall (**Figure 8**), it is clear that the top slab concrete has larger aggregate and less uniformity than modern concrete.

**Figure 8. Comparison of original top slab concrete and the more recently placed concrete for the RCP end wall interface.**

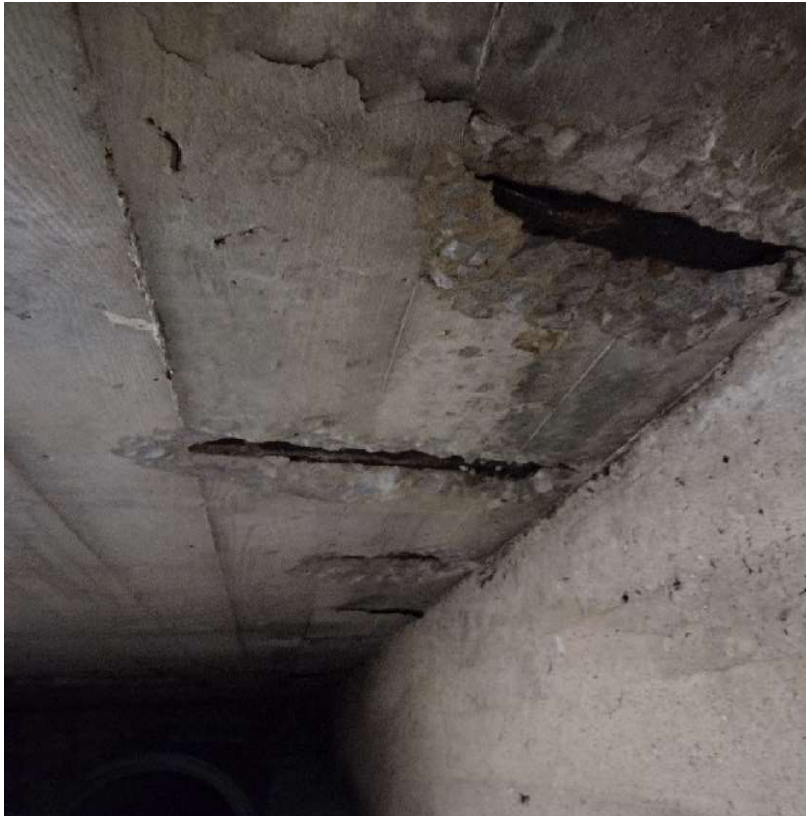
The Bloodworth St Box appeared to be extremely similar to the one at SW Worth St. The walls consisted of an unknown masonry covered with a parge coat and the riprap stream bed forming the floor. A slight difference would be that the bottom flange of the steel members in the roof slab appear to have been fully encased in concrete as opposed to the bottom flange being flush with the bottom face of the concrete slab. This may be a contributing factor to why there is less degradation of the top slab than at Worth Street (Figure 9 and 10). The amount of corrosion and spalling was much more significant in the Worth St box than the Bloodworth Street box. Even though the top slab was noted to be in better condition at this box, some notable condition issues were noted at the time of the inspection. Two full-length vertical cracks were observed in the wall of the Bloodworth junction box that could possibly be related to the gaps below the wall causing stress on the structure or settlement (**Figure 11**).

**Figure 9. Partially exposed steel beams in Bloodworth junction box top slab & showing better condition of top slab compared to Worth St**

Additionally, the exposed steel and reinforcement should be addressed similarly to the box at Worth Street. A rust inhibitor would be applied to the exposed steel to help stop corrosion and the concrete spalling it leads to. Non-shrink grout could be used to fill any large voids (such as the exposed reinforcement shown in Figure 15) to help create a more uniform surface for the proposed cementitious lining. This will aid in stabilizing and sealing off areas that may not be easily lined. This coating and any grout fill would be applied prior to the already proposed cementitious coating that will line the interior of the box as part of the I/I remediation. While this will not act as a permanent fix to the existing conditions, it should be adequate to keep conditions from deteriorating further and extend the useful life of the existing system.

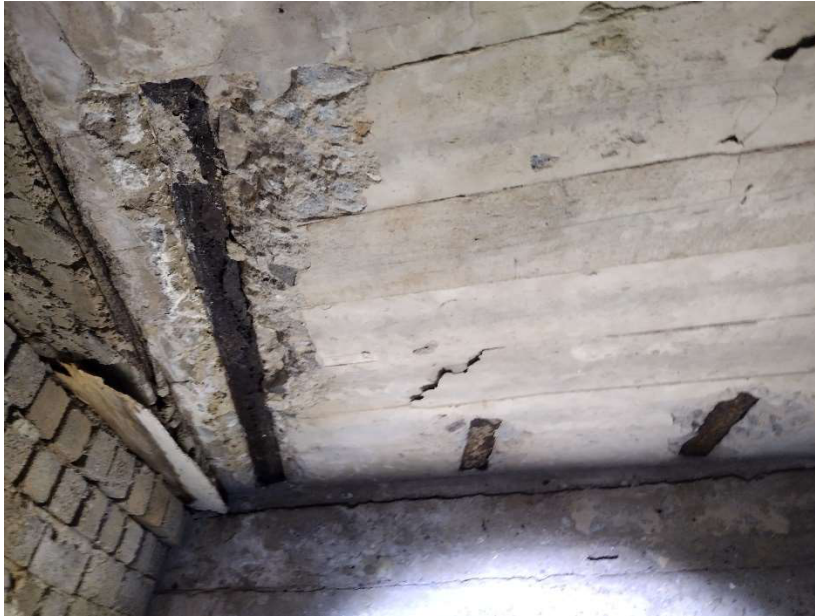
**Figure 10. Partially exposed steel beams in Bloodworth junction box top slab & showing better condition of top slab compared to Worth St**

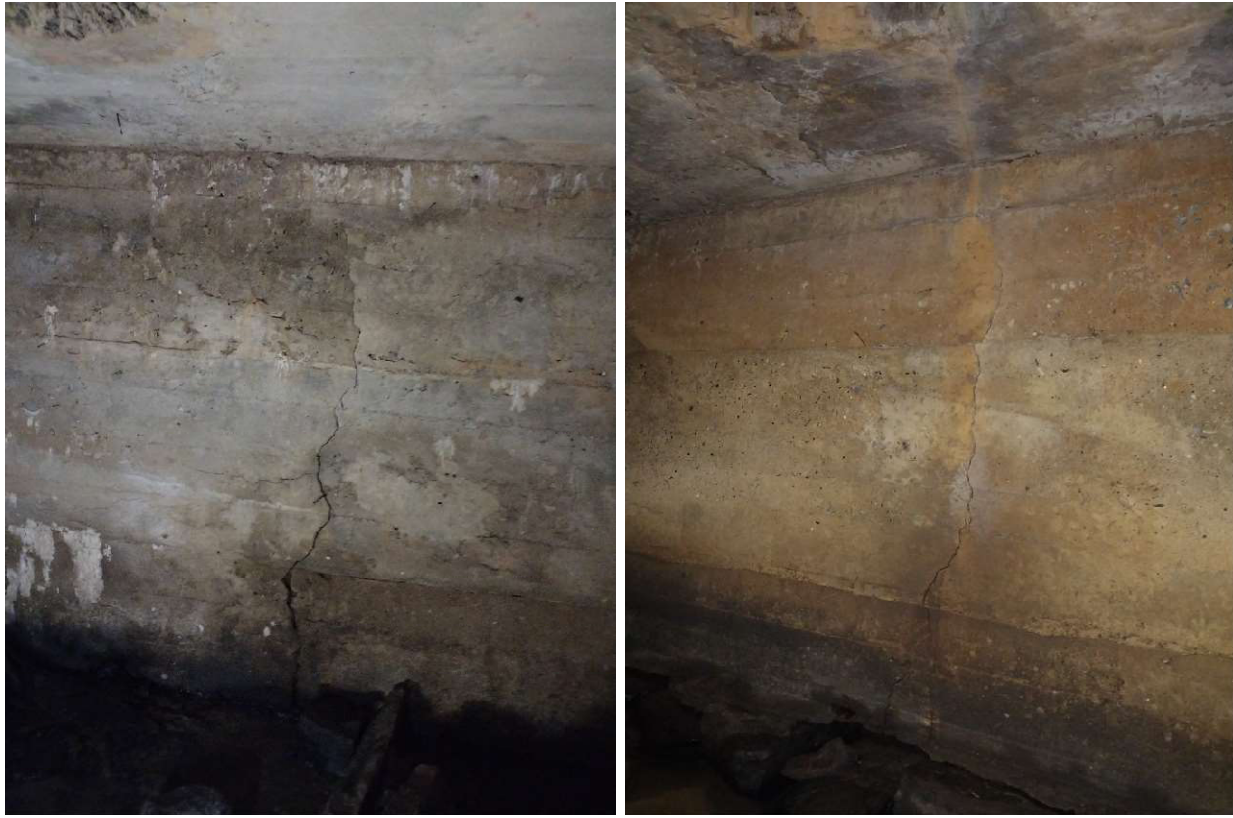
**Figure 11. Unrepaired vertical cracks in wall of Bloodworth junction box**

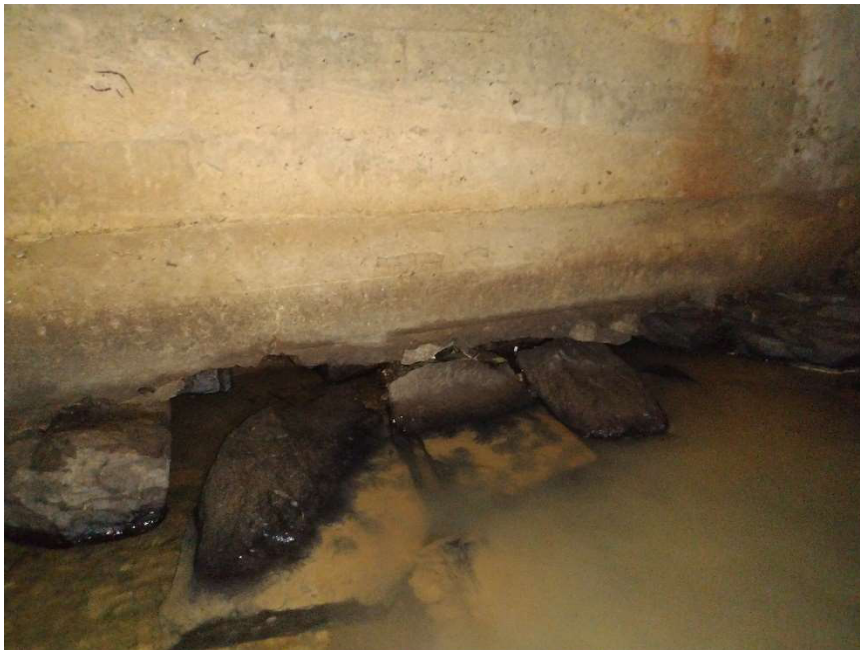
In the Bloodworth junction box, there was at least one location where there was a significant void below the wall (**Figure 12**). The streambed of this box varied more in elevation and looks to potentially be experiencing mild scour. It is also possible that these gaps below the wall are allowing for infiltration or erosion behind the wall.

**Figure 12. Noticeable void below the wall of Bloodworth junction box wall.**

Based on the observed conditions, CDM Smith recommends adding the Bloodworth Street Box to the Phase 1 rehab project specifically to fill in the voids at the base of the walls.

The first option would be filling and sealing the locations where there are currently large voids and erosion is taking place. The most likely method for filling the voids would be pumped grout with formwork. This should be done to not only fill the voided area directly below the walls, but also any that are present on the other side of the wall that erosion may have caused. The placement of grout to seal up the area at the base of the wall and stream bed should help stabilize the wall and stop any additional erosion at these locations.

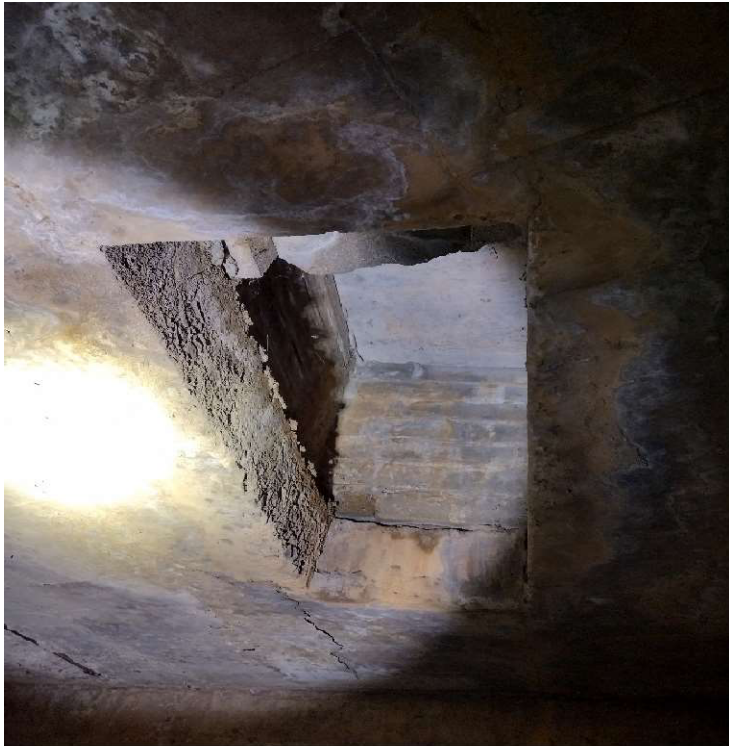
A cutout in the Bloodworth box appeared to show roughly a 5- to 6-inch-thick slab at that location, which is consistent with the estimated thickness of the box at Worth Street (**Figure 13**).

**Figure 13. Opening in top slab of Bloodworth box**

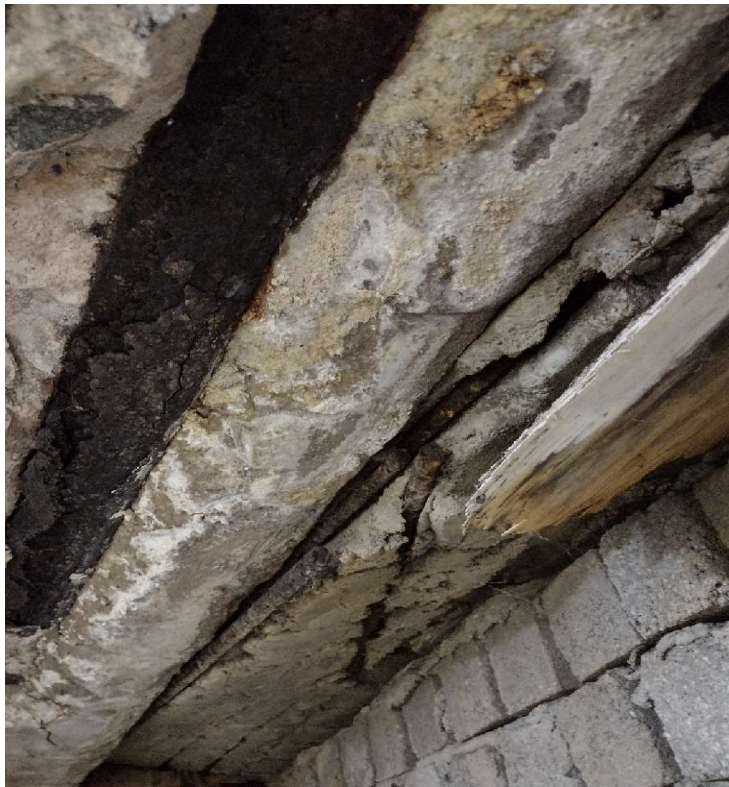
Another issue observed in the Bloodworth St junction box, was exposed rebar at the closures between the RCP end walls and the top slab of the box. At the one end, it appears that some of the reinforcement is not properly spliced or tied and was pushed downward during concrete placement (**Figure 14**). The other end seems to have continuous reinforcement, but the bars were either set too low or not enough concrete was placed to fill in below the bars (**Figure 15**).

**Figure 14. Exposed, unspliced reinforcement at one end of Bloodworth St junction box at transition of original top slab to newer RCP end wall.**

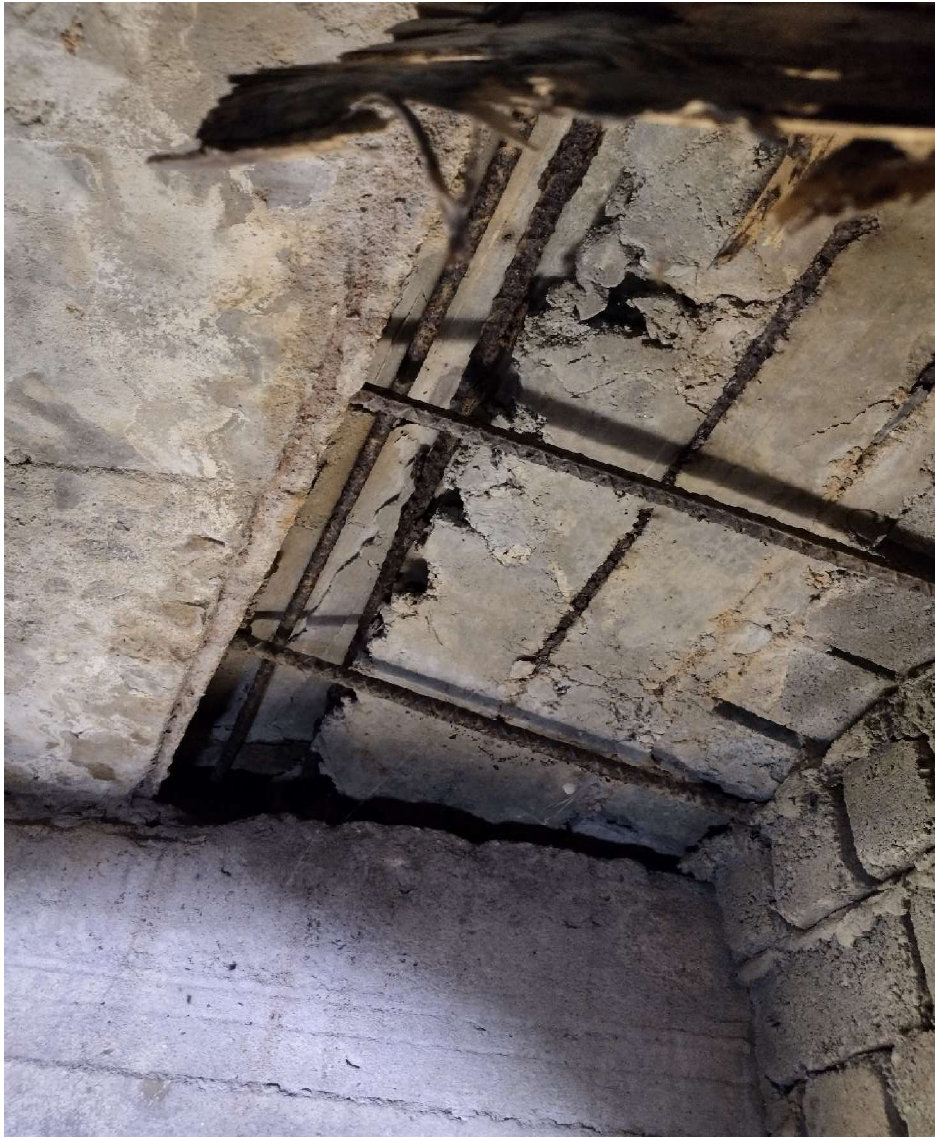
**Figure 15. Exposed reinforcement at one end of Bloodworth St junction box at transition of original top slab to newer RCP end wall.**
