ADDENDUM 01

Project: Historic Humber House Repairs
SCO #: 23-26910-01A

LYSAGHT & ASSOCIATES, P.A. – STRUCTURAL OBSERVATION REPORT

Date: April 22, 2024
Recipient: Yujie Cui
Email: yujie@clearscapes.com
Subject: Structural Field Report
Project: Robert Lee Humber House Structural Observation
Site: 117 W 5th St, Greenville, NC 27858
Project #: 14520 (L&A)
Visit Date: April 10, 2024

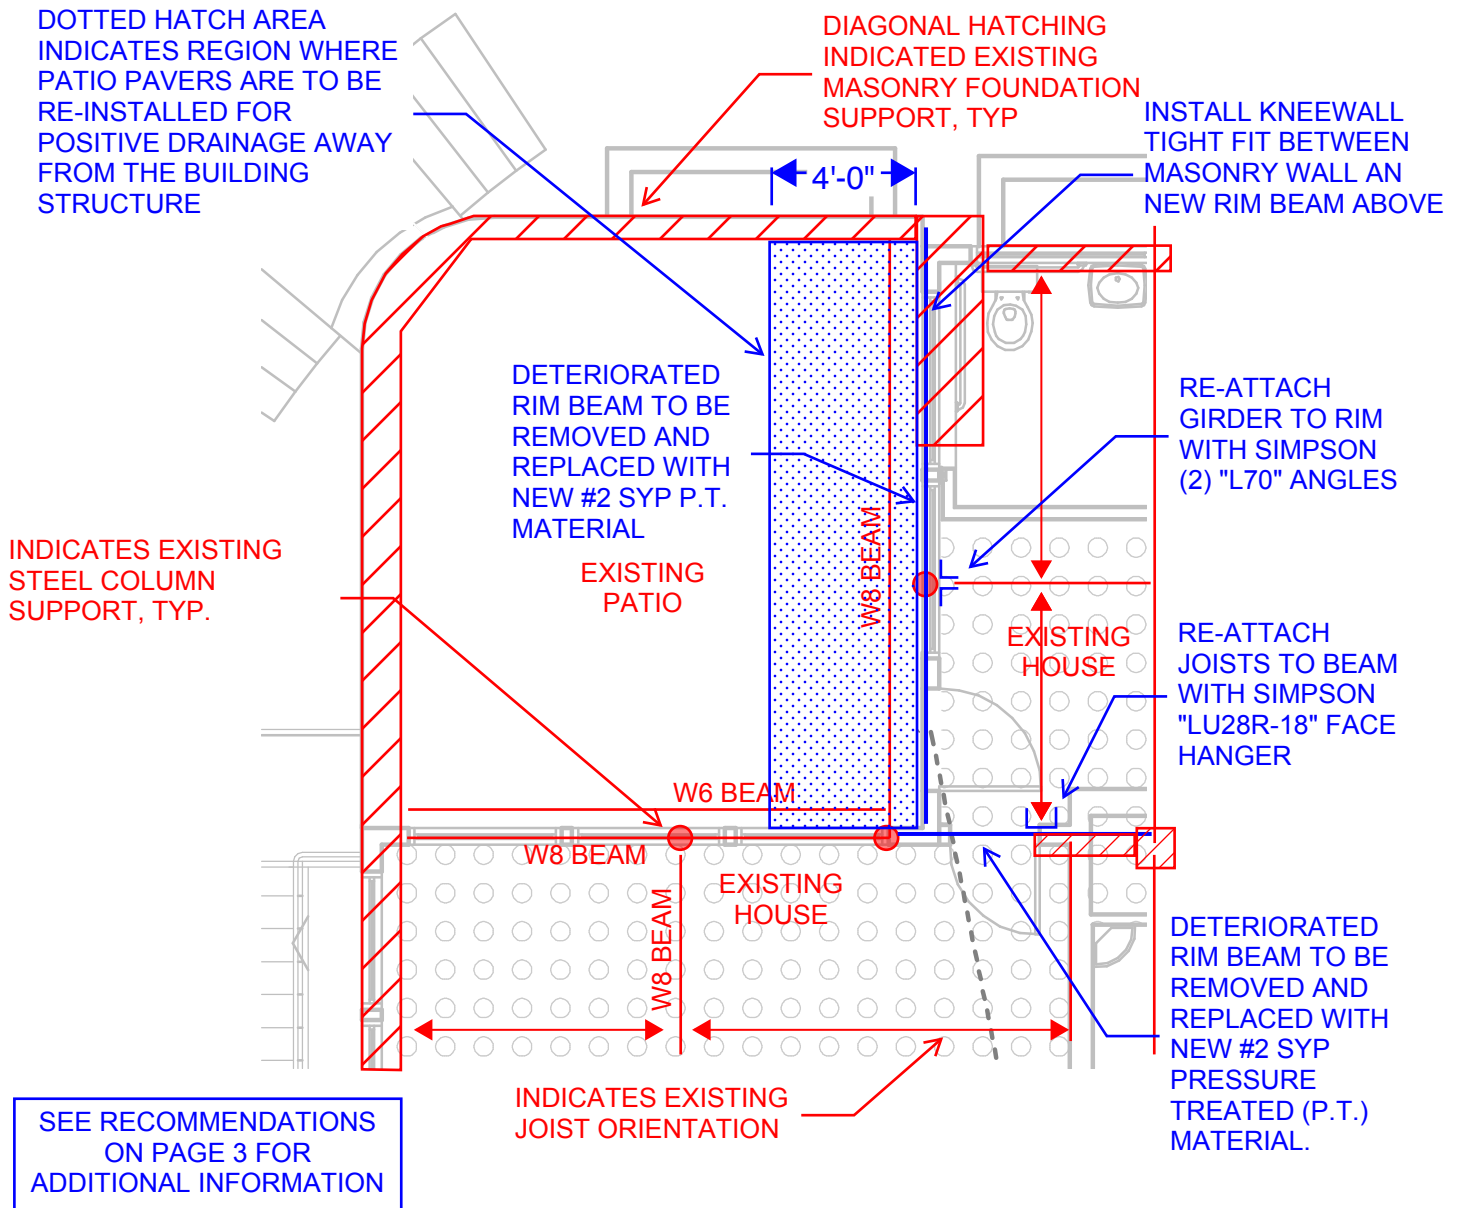
PARTIAL 1ST FLOOR FRAMING SCHEMATIC

- i. In addition, the beam located at the front of the rim band was noted to be deteriorated beyond salvageable limits (*see picture 7 for example*) (*see schematic on page 3 for additional information*).

- 1) The deteriorated rim band shall be removed and replaced with new (2)2x10 rim band, ripped down to a depth of approximately 8", such that the top of beam is flush with bottom of floor sheathing and bottom of beam is flush with the cap plate of the existing steel column.

- a. The new rim band shall have full bearing at the back foundation wall, and shall be attached to beam at front with Simpson face hanger.
 - i. Attach steel column cap plate to new rim beam with (2) ¼" x 4½" Simpson SDS screws. Drill 5/16" diameter holes in existing steel cap plate for attachment.

- 2) The existing left-to-right single ply beam/rim that supports the front-to-back deteriorated rim noted above shall be removed and replaced with a (2)2x10 beam, ripped down to a depth of approximately 8", such that the beam is flush with the underside of sheathing and with the top of end bearing supports (*see schematic on page 3 for additional information*).

- a. Joists shall be attached to new beam with Simpson "LU28R-18" face hangers.
- 3) We recommend that the 4' wide section at the right side of the back patio be sloped 1/8" per foot minimum, and that the 1' section directly adjacent to the structure at the right side of the patio shall be sloped away from the structure 3/16" (minimum) over one foot.

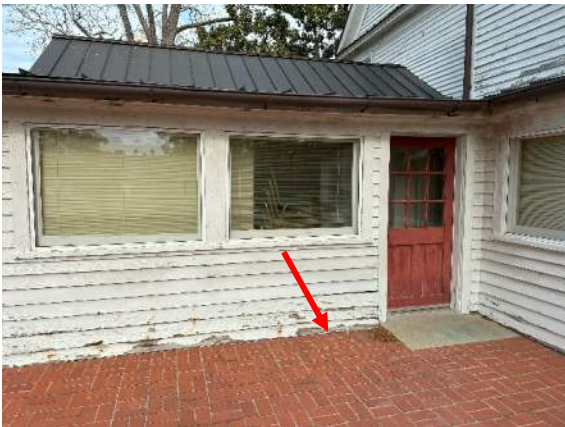
- 1) While on site, it was reported that a water-intrusion issue has been present in the basement beneath the transition from the right side of the elevated exterior patio slab and the exterior wall of the building (*see pictures 2-3 for examples*).
 - a. Further investigation beneath the patio slab revealed that the single 1 $\frac{3}{4}$ " x 7 $\frac{3}{4}$ " partially sistered rim band, beneath the left wall of the back-most portion of the building was deteriorated beyond salvageable limits (*see pictures 4-6 for examples*).

*Picture 3 – Example of area of reported water-
intrusion*

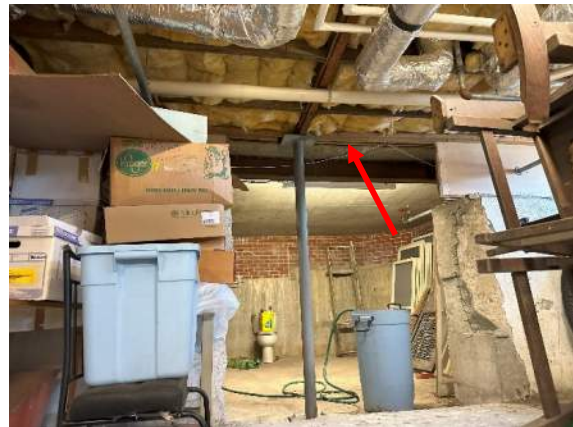
*Picture 4 – Example of area of reported water
intrusion*

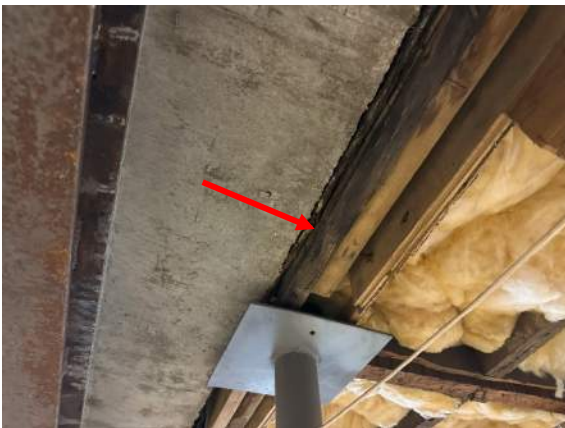
- 1) The above-noted deteriorated rim band and reported water intrusion into the basement at the right side of the back patio is likely the result of a combination of inadequate slope at the right side of the patio slab and loose/inadequately sealed waterproofing (flashing).

*Picture 5 – Example of partially sistered,
deteriorated rim band*

- b. Once the existing rim band has been removed, the contractor shall inspect the condition of the floor sheathing above. If the sheathing is deteriorated, it shall be removed and replaced with sheathing of matching thickness. Sheathing shall span across (2) joists bays minimum and shall be fastened to floor joists with 8D common nails at 6" o.c. at panel edges and 12" o.c. in the panel field.

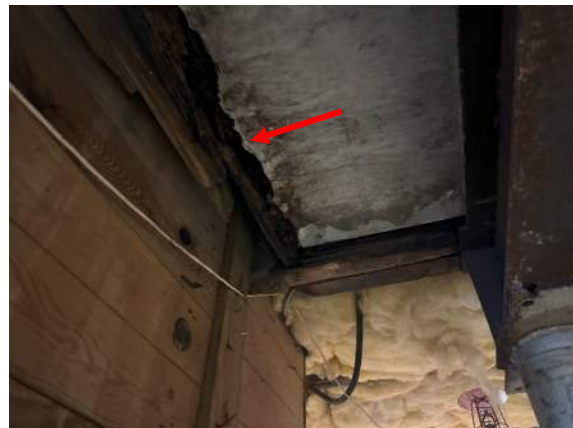
*Picture 6 – Example of partially sistered,
deteriorated rim band*

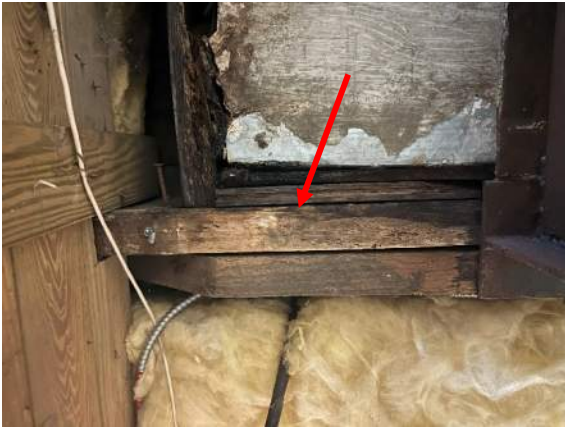
Picture 7 – Example of deteriorated beam at front side of deteriorated rim (pic 6)

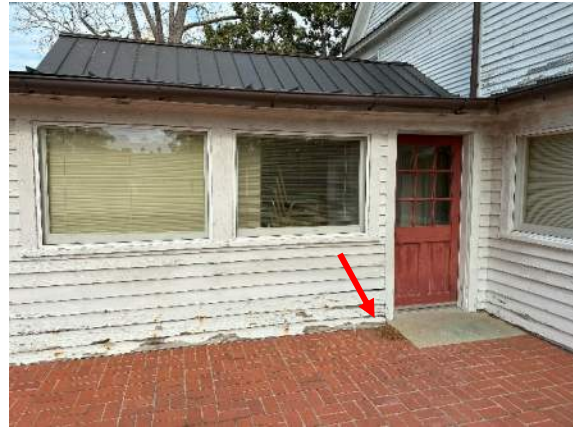
- e. When measured at the 2' section located directly adjacent to the left wall of the back-most bump-out, it was noted that the patio surface was not adequately sloped for positive drainage away from the building structure.

- i. Signs of standing water were noted adjacent to the concrete entry ramp at the left wall of the back-most bumpout (*see picture 8 for example*).
- 2) At the time of our site visit, Reid Thomas (NC State Historic Preservation Office) offered to remove the bottom (2) boards of siding from the exterior wall of the structure at the right side of the back patio.

Picture 8 – Example of debris pile as evidence of previously standing water

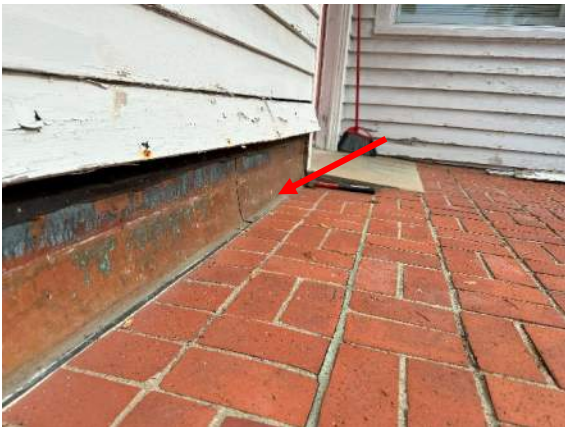
- a. Upon removal, it was revealed that flashing was not adequately sealed to the brick patio structure (*see pictures 9-10 for examples*).

Picture 9 – Example of existing flashing at right side of patio

- a. If brick pavers are to be removed to provide the required slope, care should be taken to not damage the top surface of the slab below.
 - b. Once the patio surface has been sloped per the requirements above, new flashing/waterproofing shall be installed between the exterior wall of the building structure and the existing patio slab.

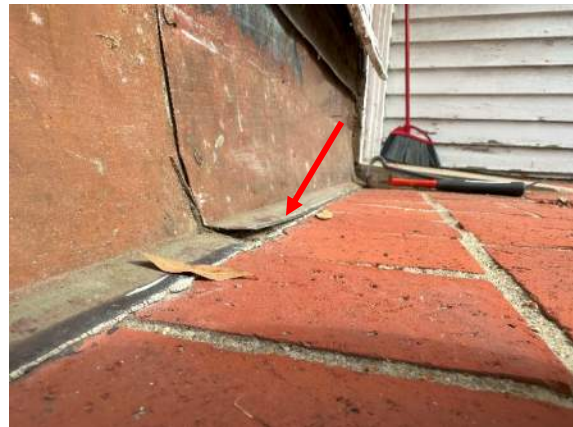
Picture 10 – Example of existing flashing at right side of patio
