Subject: Stantonsburg 2022 CDBG-NR Project
Request for Bid Proposals for Demolition and Asbestos Removal

PROPOSALS OF ASBESTOS REMOVAL DEMOLITION/CLEARANCE OF STRUCTURES

Re: Limited Asbestos Inspection Report
104 W. Julian Ave.
Stantonsburg, NC 27883

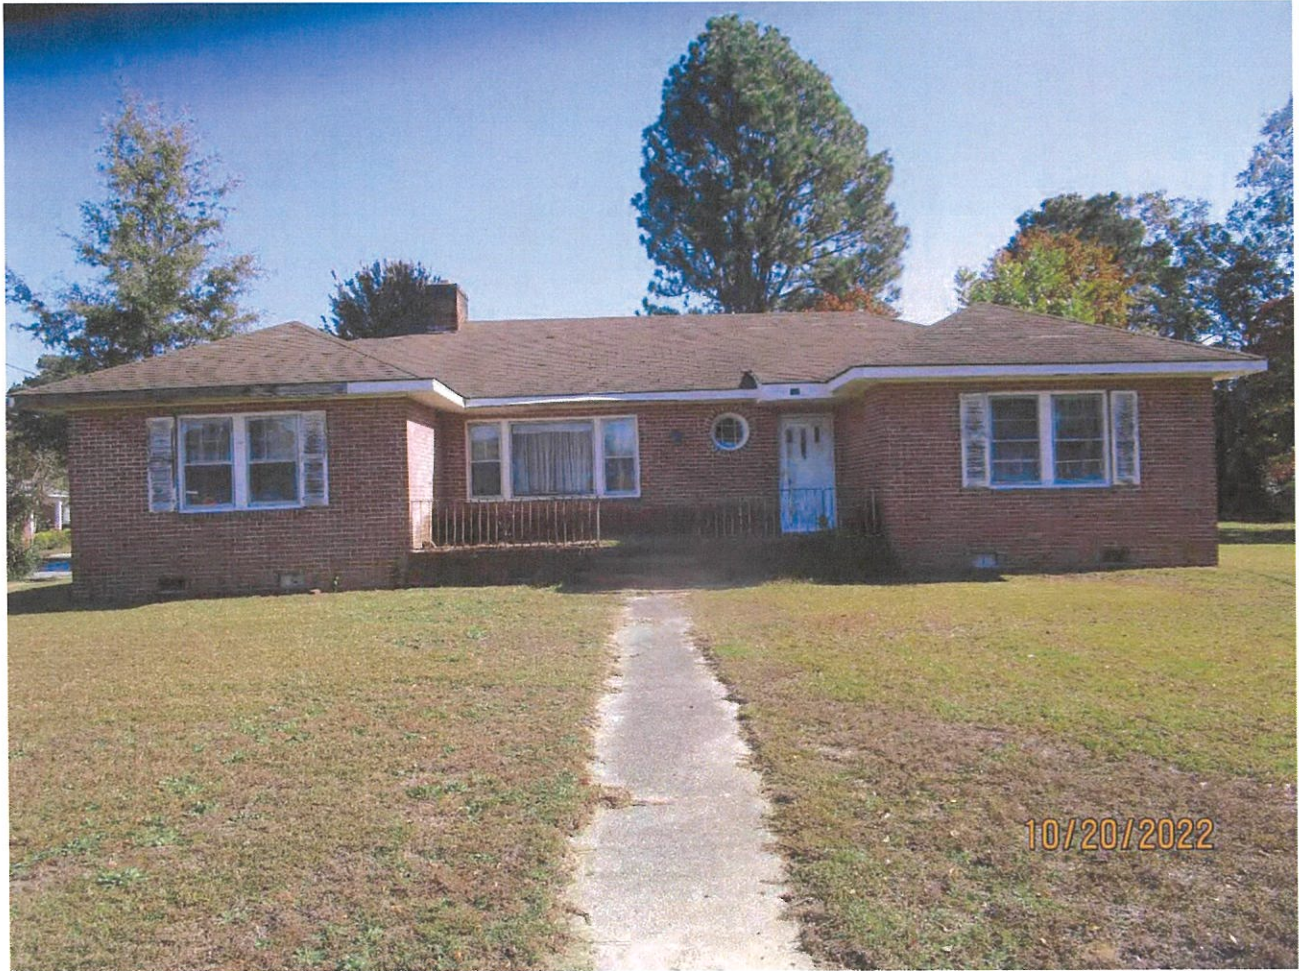
Mary Ellis, 104 W. Julian Avenue, Stantonsburg, NC 27883

Completely demolish the house structure from the property. Remove all debris/garbage around the house. Completely remove concrete driveway from house to city concrete sidewalk approximately 19' feet x 39' feet. Remove small concrete sidewalk next to house approximately 6' feet x 14' feet. Remove front concrete sidewalk approximately 34' feet x 4' feet. Remove circular concrete sidewalk approximately 22' feet x 3' feet at front next to city concrete sidewalk. Do not damage any city concrete sidewalks. Completely remove 15 trees. Remove one tree at right front corner of house. Remove six trees at right side of house. Remove two trees at rear of house next to HVAC units. Remove two large trees, limbs, small logs, large tree trunk laying on ground. Remove debris around two large trees at chain link fence and small brick wall area. Remove three trees at left side of house near concrete sidewalk. Remove one tree at left front corner of house. Including removal of all tree stumps below ground level and large roots above ground. Grade site, clean and level. Haul in sufficient fill dirt to cover holes and disturbed areas and to provide positive drainage. Cost of dirt to be included in lump-sum proposal. Re-seed and hay disturbed areas. Proposal to be turnkey and to include all costs of disposal, including tipping fees to County landfill, labor, materials, permits, demolition permits, insurance, etc. Contractor is to provide copies of landfill tickets and proof of payment to the landfill. Contractor is to provide copies of invoices and proof of payment for any subcontractors that perform any work at job site. Contractor shall obtain and provide copy to the Town of Stantonsburg, Demolition Notification Permit from NC Health Hazards Control Unit (HHCU). Chain link fence to remain.
