**PHASE I ENVIRONMENTAL SITE ASSESSMENT
HUGHES STREET PROPERTY (± 12.43 ACRES)
APEX, WAKE COUNTY, NORTH CAROLINA**

**PROJECT NO. 25003620.001A | RAL25R177609
February 3, 2025**

**PREPARED FOR:
TOWN OF APEX
TRANSPORTATION AND INFRASTRUCTURE
DEPARTMENT
PO BOX 250
APEX, NC 27502**

**PREPARED BY:
KLEINFELDER, INC.
200 REGENCY FOREST DRIVE,
SUITE 225
CARY, NORTH CAROLINA 27518**

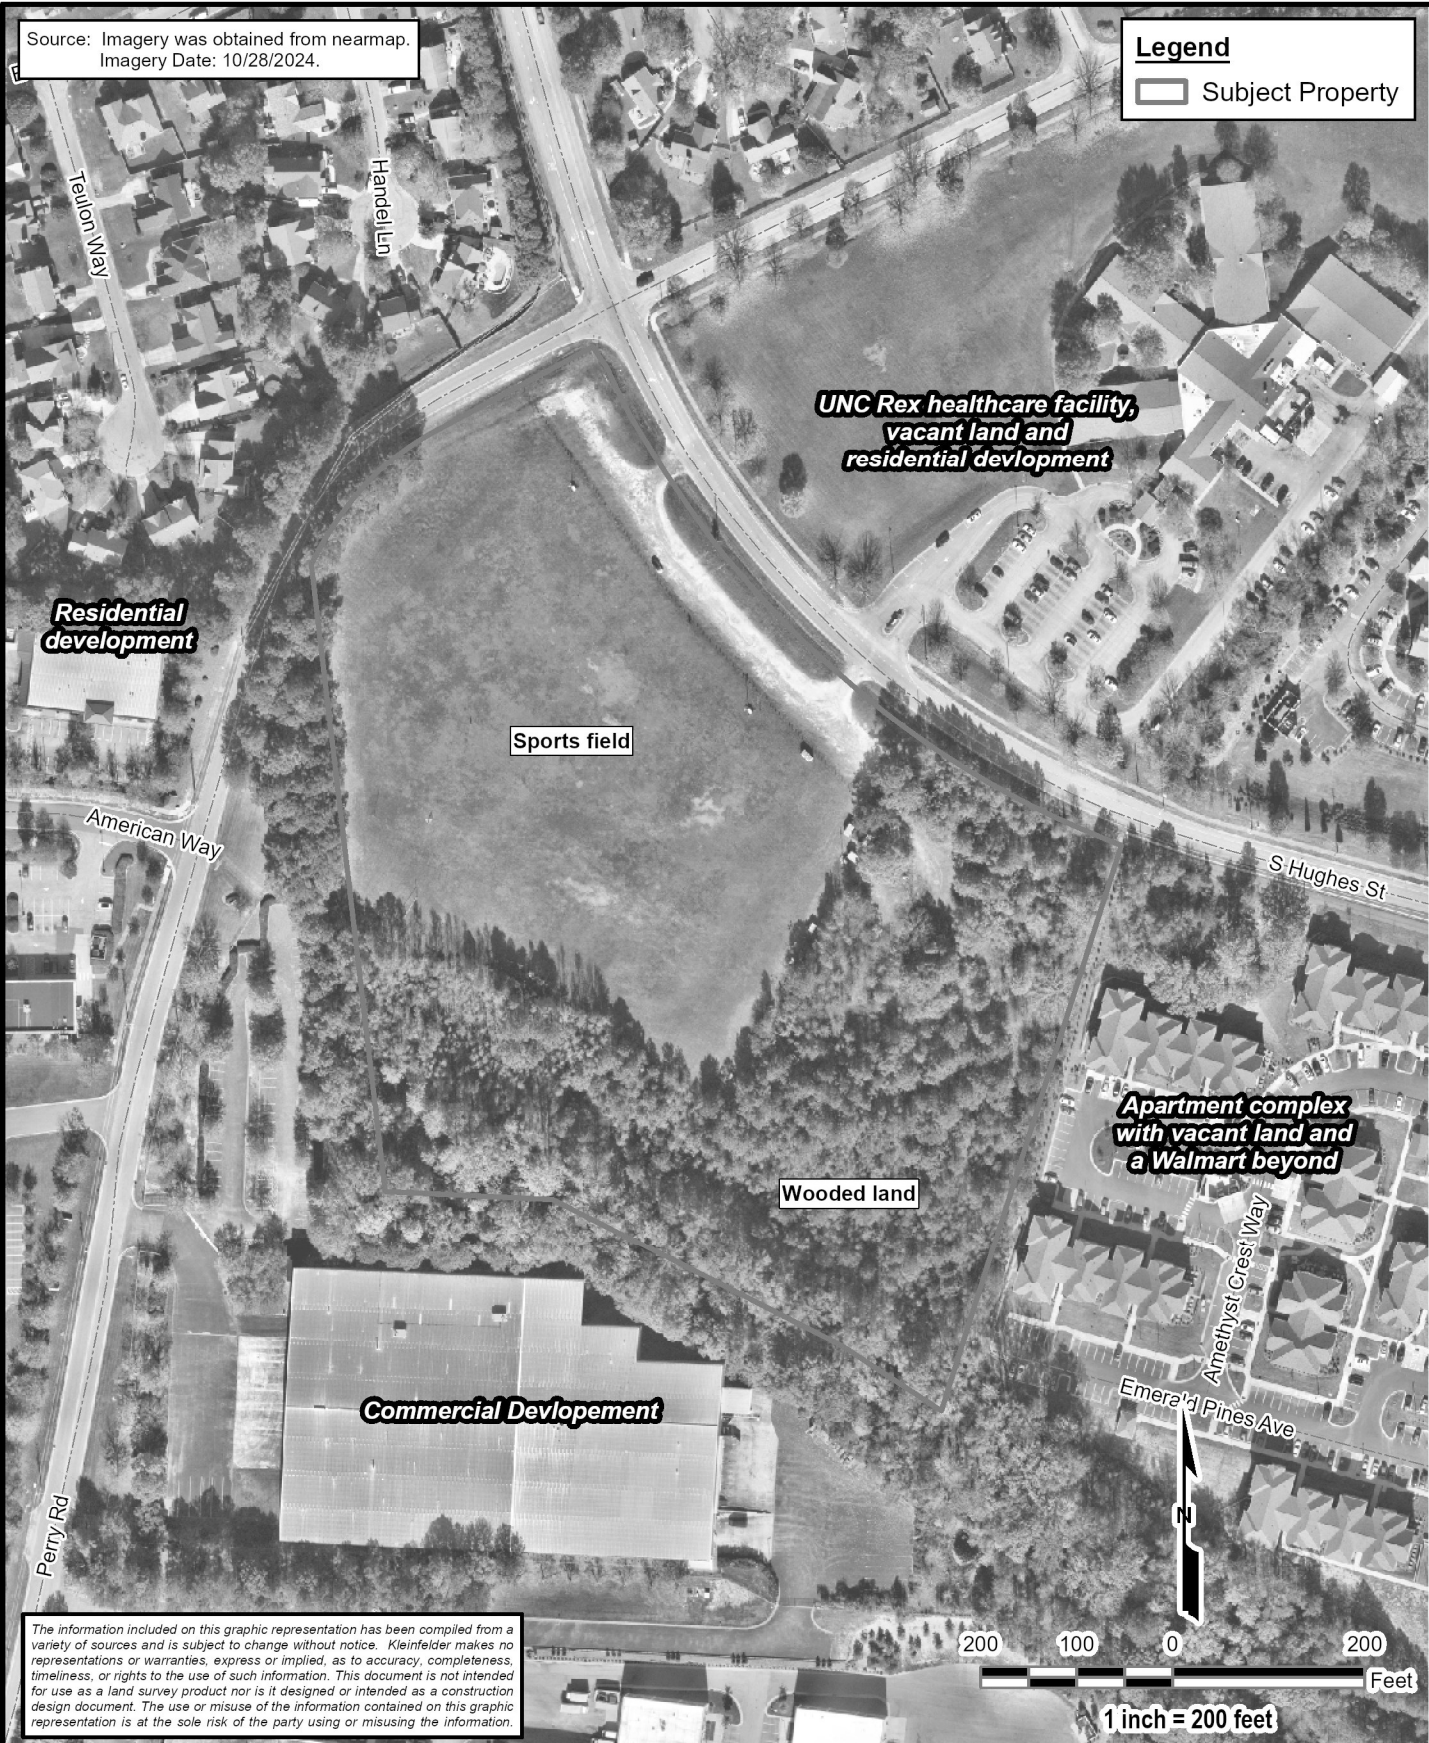
Mr. Michael Burns of Kleinfelder performed the Subject Property reconnaissance on January 20, 2025. The Subject Property reconnaissance included a visual observation of the Subject Property to assist in identifying the presence or likely presence of hazardous substances or petroleum hydrocarbons under conditions that indicate an existing release, a past release, or threat of release into structures, soil, groundwater, or surface water at the Subject Property (i.e., RECs). Observations of readily apparent environmental conditions are summarized in Table 6-1, and color photographs of the Subject Property are presented in Appendix F. The approximate Subject Property boundaries are shown on Figure 2.
