ADDENDUM 01

Project: Historic Humber House Repairs
SCO #: 23-26910-01A

LYSAGHT & ASSOCIATES, P.A. – STRUCTURAL OBSERVATION REPORT

Date: April 22, 2024
Recipient: Yujie Cui
Email: yujie@clearscapes.com
Subject: Structural Field Report
Project: Robert Lee Humber House Structural Observation
Site: 117 W 5th St, Greenville, NC 27858
Project #: 14520 (L&A)
Visit Date: April 10, 2024

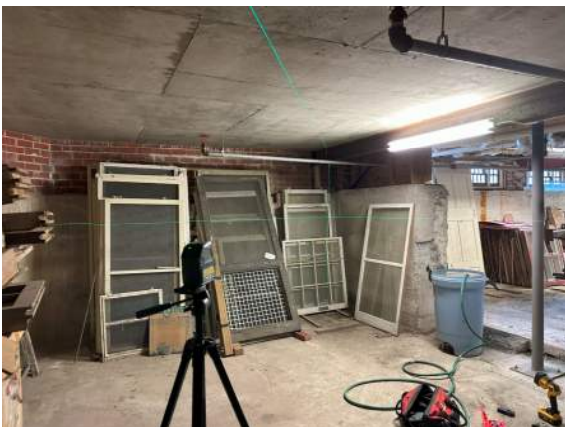
- b. Measurement by laser level indicated that steel beam supports for the patio slab were not sagging beyond allowable limits at the time of our site visit.

Picture 11 – Example of laser level set up for measurement of existing beams and underside of patio slab

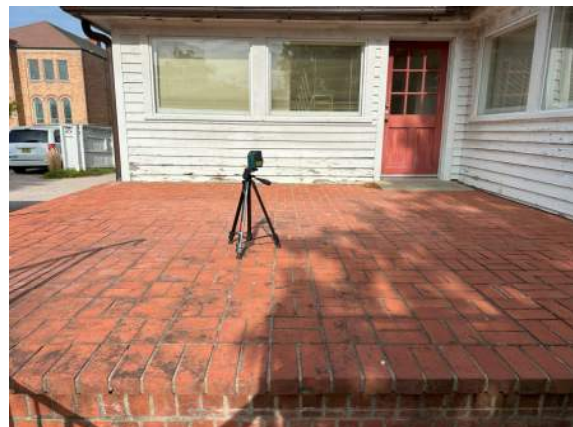
Picture 12 – Example of laser level set up for measurement of existing patio slab surface

- a. Joists shall be attached to new beam with Simpson "LU28R-18" face hangers.
- 3) We recommend that the 4' wide section at the right side of the back patio be sloped 1/8" per foot minimum, and that the 1' section directly adjacent to the structure at the right side of the patio shall be sloped away from the structure 3/16" (minimum) over one foot.
